## Fairfield park, Stotfold, Hertfordshire

### Alan Randall of The Blue Tree Company

#### Client: Hislop Horticulture

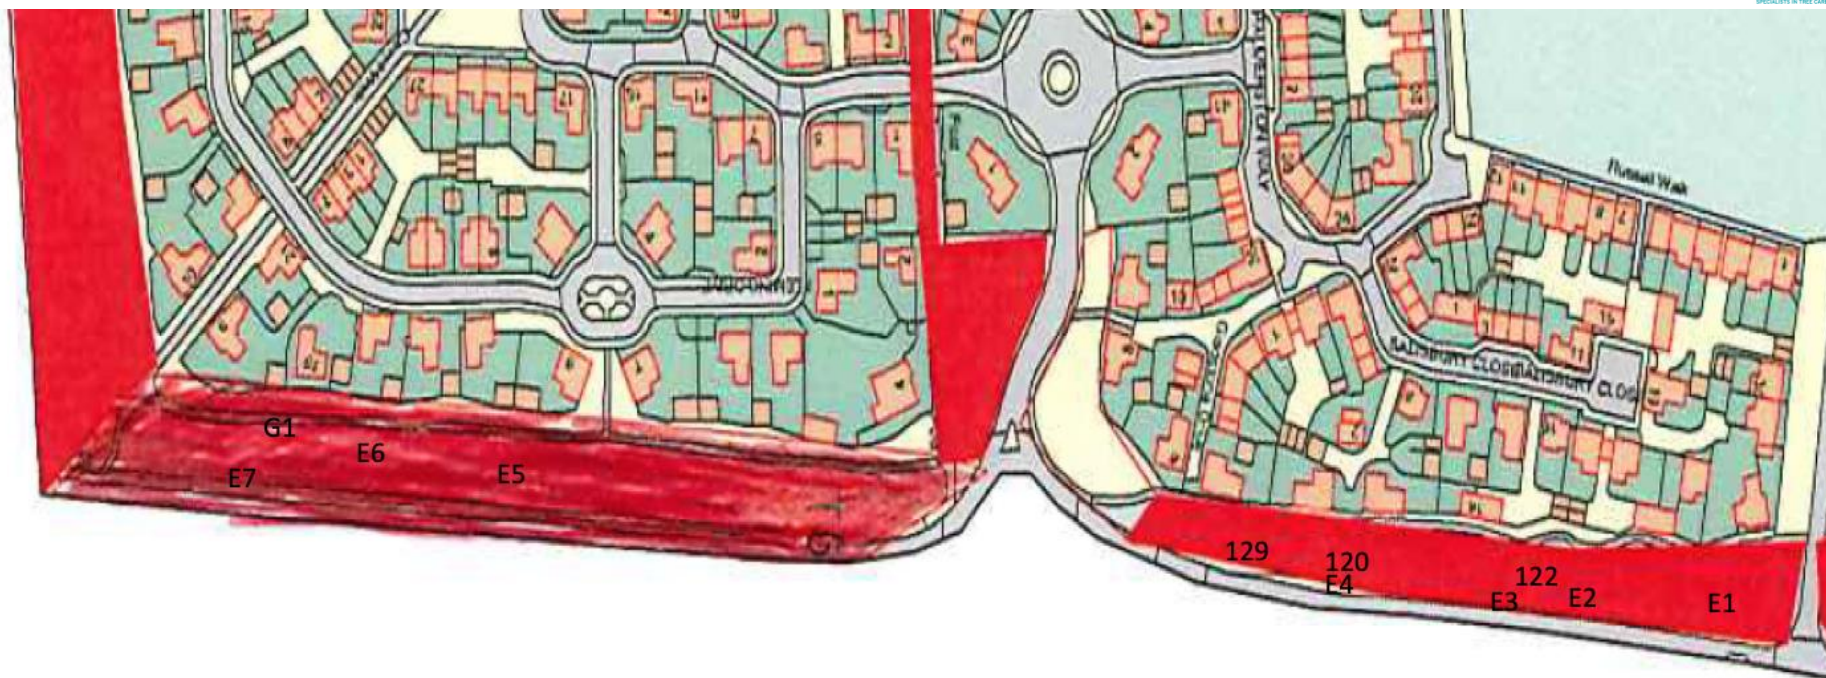
Eastern Boundary site map: Note: Tree positions are indicative only.

Eastern Shelter Belt						
Ref No	species	Height (M)	Age Class	Condition	Recommendation	Time frame (Months)
E1	Poplar	10	M	Poor. Historic attempt to rejuvenate the tree have failed. The tree is now standing dead and decaying at the reduction points. The tree is well with falling distance of a busy public highway	Reduce height by 4m.	6
E2	Ash	15	M	Poor. Bracket fungi <i>Inonotus hispidus</i> noted on the west side at 3m within an included bark union. Obvious decay also noted at this point. The tree is well with falling distance of a busy public highway.	Fell to ground level or reduce to a habitat pole at 4m.	6
T112	Sycamore	20	M	Various cavities on the main stem and throughout the crown. Some significant dead wood is present.	Climbing inspection off cavities and unions. Remove dead wood.	6
E3	Elm x 3 Located road side of T112	4	M	Dead. The tree is well with falling distance of a busy public highway.	Fell to ground level	6

T120	Sycamore	18	M	Reasonable. Included bark union in the main union at 3m. no significant support wood noted.	Crown reduce by up to 4m back to good viable growth points	6
E4	Sycamore Located rear right roadside of T120	16	M	Reasonable. Bark wound at base with minor decay noted. Hammer tap+ sound. Significant dead wood over public highway.	Remove dead wood over public highway	3
T129	Scots pine	15	M	Poor. Showing signs of significant crown die back	Pay special attention to this tree at the next tree survey	
E5	Ash	13	EM	Good. Recent branch failure at the point of an included bark union to the east. Remaining limb is unstable. Over the public highway.	Remove remaining limb	6
E6	Scots pine	14	M	Dead	Fell to ground level	3
G1	Sycamore x 3	16	M	Group of 3. Significant dead wood over footpath	Remove dead wood	3
E7	Horse chestnut	16	M	Ivy covered main stem to 3m preventing full VTI. Included bark union at 4m with little support wood. Historic lower limb fail.	Crown reduce by up to 4m back to good viable growth points.	6

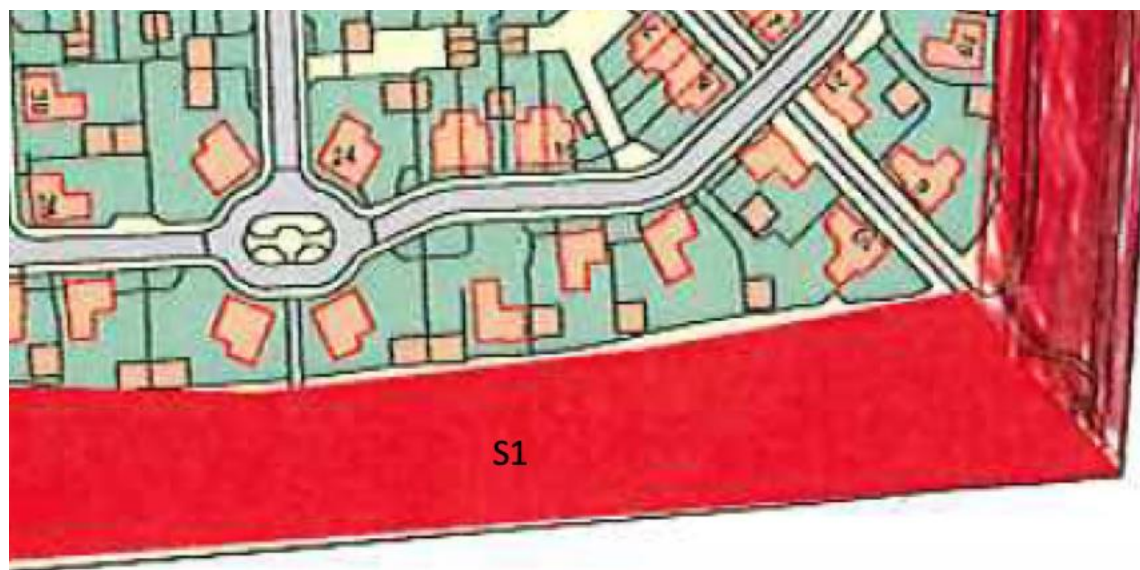
Sothern Boundary site map: Note: Tree positions are indicative only.

Ref No	species	Height (M)	Age Class	Condition	Recommendation	Time frame (Months)
S1	Ash	12	M	Significant dead wood over public footpath.	Remove dead wood	3

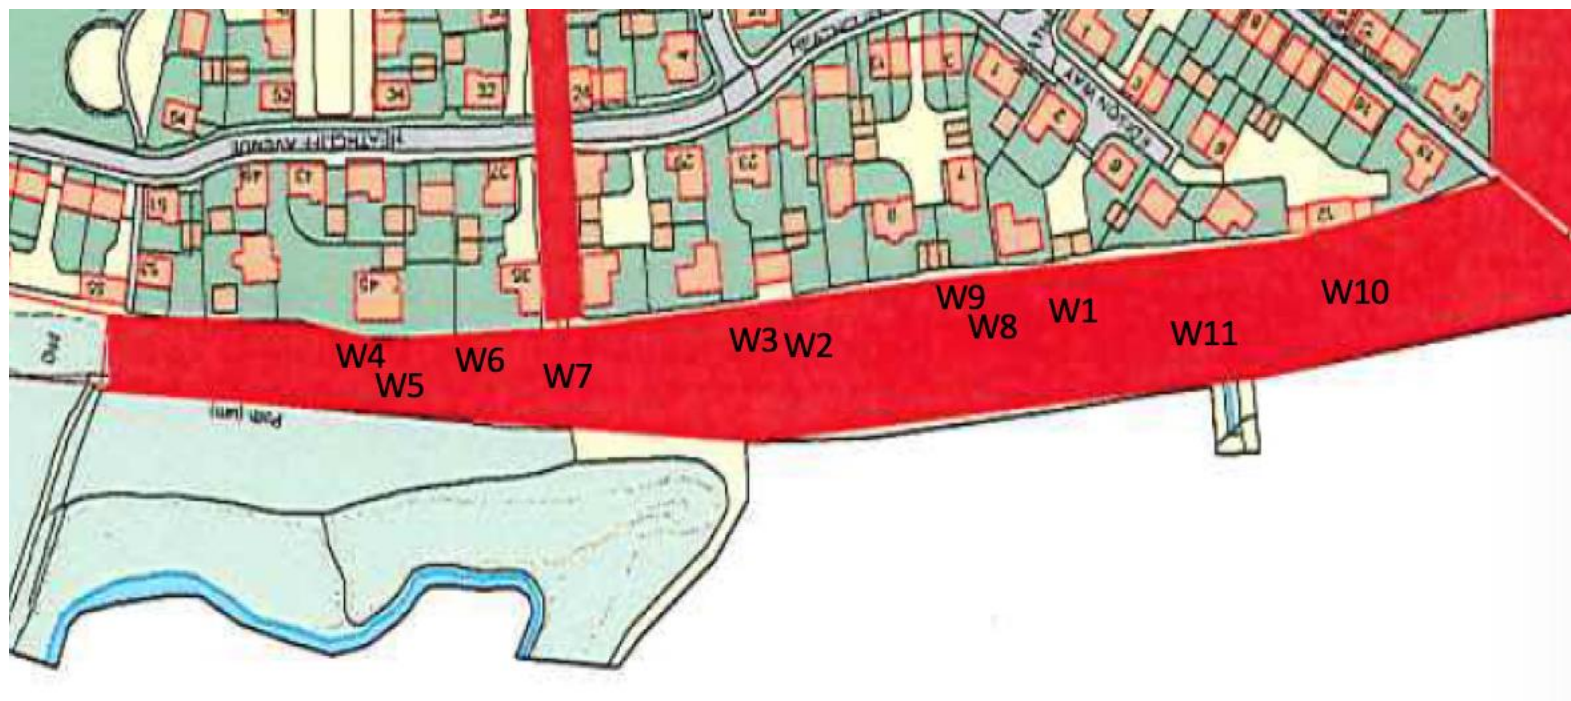
Western Boundary site map: Note: Tree positions are indicative only.

<u>Western Shelter Belt</u>						
Ref No	species	Height (M)	Age Class	Condition	Recommendation	Time frame (Months)
W1	Sycamore x 2 Outside No 25	12	EM	Dead. Within falling distance of a public footpath	Fell to ground level and stack in eco piles on site.	3
W2	Elm x 5	5	EM	Dead. Within falling distance of a public footpath	Fell to ground level and stack in eco piles on site.	3
W3	Elm x 4	5	EM	Dead. Within falling distance of a public footpath	Fell to ground level and stack in eco piles on site.	3
W4	Sycamore	13	M	Poor. Large canker with signs of decay at 4m on the east side. Outer canopy is sparse and showing signs of die back.	Pollard to 6m	6
W5	Beech	20	M	Large open cavity at ground level on the east side. Probed to 20cm. Black exudates at 1.5m on the west side indicating an infection of <i>Phytophthora</i> .	PISCUS scan/Resistograph drill to ascertain the extent of decay.	ASAP
W6	Sycamore	13	EM	Group of 5 young trees. Suffering with sooty bark disease.	Fell to ground level	6

W7	Ash	11	OM	Advanced decay at base. Historic heavy pollard Leaning on adjacent tree. Leaning over public footpath	Fell to ground level and stack in eco piles on site.	3
W8	Ash Outside 25	16	M	Tree in decline. Bacterial infection noted at base to 2.5m. Habitat holes noted	Pollard to approximately 10m at least 1m above the habitat holes.	6
W9	Ash	13	M	Historic pollard. Large bracket of <i>Inonotus hispidus</i> noted on the main stem at 3m on the south east.	Re pollard to the old points	6

<u>Western Shelter Belt</u>						
Ref No	species	Height (M)	Age Class	Condition	Recommendation	Time frame (Months)
W10	?	6		Fallen, hung up dead tree covered in ivy. Close to a public footpath	Fell to ground level and stack in eco piles onsite	12
W11	Scots pine	23	M	Tree in decline, no obvious cause 90% of the canopy has died. Canopy should be investigated at the time the tree work is carried out.	Pollard to leave a 10m Habitat pole.	12

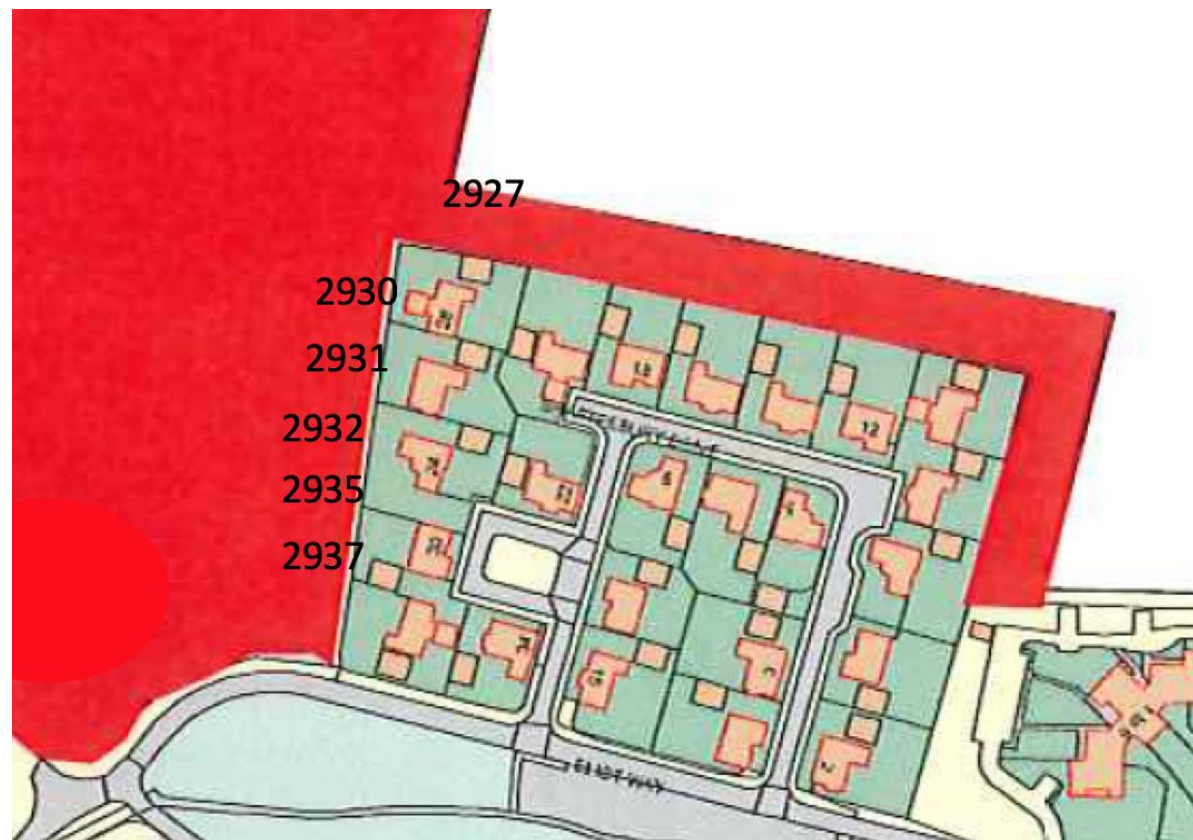
Northern Boundary site map: Note: Tree positions are indicative only.

<u>Northern Shelter Belt</u>						
Ref No	species	Height (M)	Age Class	Condition	Recommendation	Time frame (Months)
T2937	Horse Chestnut	16	M	Advanced Bleeding canker noted on the main stem and throughout the canopy. Secondary limbs starting to suffer bark loss and cambium degradation. Historic crown reduction at 14m. Over hanging private property.	Repeat crown reduction and reduce back from property by up to 2m. back to good viable growth points.	12
T2935	Horse Chestnut	9	M	Cavity at base on the east side. Hammer tap and probe = solid. Significant longitudinal crack noted on the first main limb to the east 2.5m up 1m out. Bark damage on the upper side of the first main limb to the west, no significant decay noted. Bleeding canker noted on the main stem.	Remove first main limb to the east.	12
T2932	Horse Chestnut	9	M	Advanced Bleeding canker noted on the main stem and throughout the canopy. Secondary limbs starting to suffer bark loss and cambium degradation.	Crown reduce by up to 2m back to viable growth points	12

T2931	Horse Chestnut	11	M	Advanced Bleeding canker noted on the main stem and throughout the canopy. Secondary limbs starting to suffer bark loss and cambium degradation. This is more advanced on the east side	Crown reduce by up to 2m back to viable growth points	12
T2930	Horse Chestnut	11	M	Advanced Bleeding canker noted on the main stem and throughout the canopy. Secondary limbs starting to suffer bark loss and cambium degradation. This is more advanced on the east side	Crown reduce by up to 2m back to viable growth points	12
T2927	Horse Chestnut	9	M	Bleeding canker noted on the main stem. Bacterial wet wood noted on the first limb to the south	Crown reduce by up to 2m back to viable growth points	12

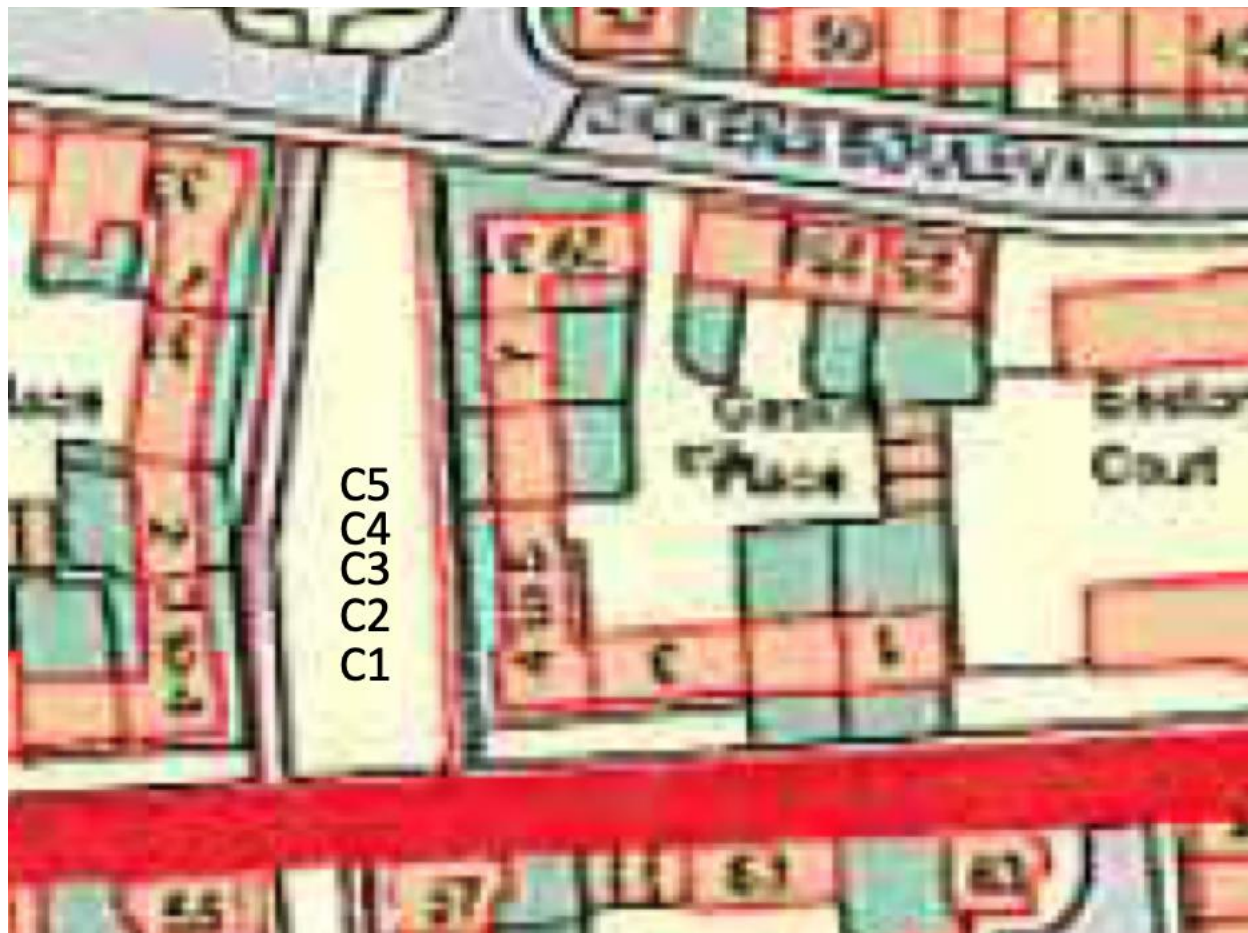
Central area site map: Note: Tree positions are indicative only.

Central area						
Ref No	species	Height (M)	Age Class	Condition	Recommendation	Time frame (Months)
C1	Robinia	13	M	Single stem remaining of a twin stem tree, the missing stem was removed some time ago. Minor decay noted at the old point of attachment. Recent main leader fail at 6m. Several historic limb fail points noted on secondary limbs. Significant dead wood throughout the crown. The condition is typical of age/species.	Crown reduce by up to 2m back to good viable growth points.	6
C2	Robinia	12	M	Twin stem. Sheltered and subdud by adjacent trees. Crown bias to the west. Minor bark wound on the main stem at 1.75m on the west side. Significant dead wood throughout the canopy typical of age/species.	Crown reduce by up to 2m back to good viable growth points.	6
C3	Robinia	14	M	Bark wound at 1.5m from a historic limb removal. Significant dead wood and decay pockets from historic limb failure.	Crown reduce by up to 2m back to good viable growth points.	6

C4	Robinia	12	M	Sheltered and subdud by adjacent trees. Crown bias to the west. Significant dead wood throughout the canopy typical of age/species. The condition is typical of age/species.	Crown reduce by up to 2m back to good viable growth points.	6
C5	Robinia	14	M	Bark damage and cavity at the base. Hammer tap and probe = solid. Significant cavity on the upper side of the limb 6m to the east. Significant dead wood throughout the crown. The condition is typical of age/species.	Crown reduce by up to 2m back to good viable growth points.	6
